FATIGUE BEHAVIOUR OF A ROLLED AZ31 MAGNESIUM ALLOYS PREPARED BY EP AND BB CONDITIONS

Abstract: Rotating bending fatigue tests have been performed using smooth specimens of a rolled AZ31 magnesium alloy in laboratory air at ambient temperature. Fatigue strength and characteristic was evaluated and fracture mechanism was discussed on the basis fracture surface analysis. Electrical polishing (EP) as well as deep rolling (ball burnishing (BB)) U-notched specimens were performed on two groups of samples, to evaluate optimum conditions for fatigue life. The microstructure and tensile properties of roll cast (RC) Mg- 3% Al- 1% Zn (AZ31) was investigated. The fatigue strength of 107 cycles around 100 MPa for deep rolling while it was around 40 MPa for Electrical polishing. It was very important to understand the effect of (ball burnishing (BB)) conditions on the hardness of the surface through to the core. The two procedures improved the fatigue performance, but better improve in results were found in ball burnishing. The growth of small cracks initiated at the surface coincided with the FCP characteristic after allowing for crack closure for large cracks, but the operative fracture mecha

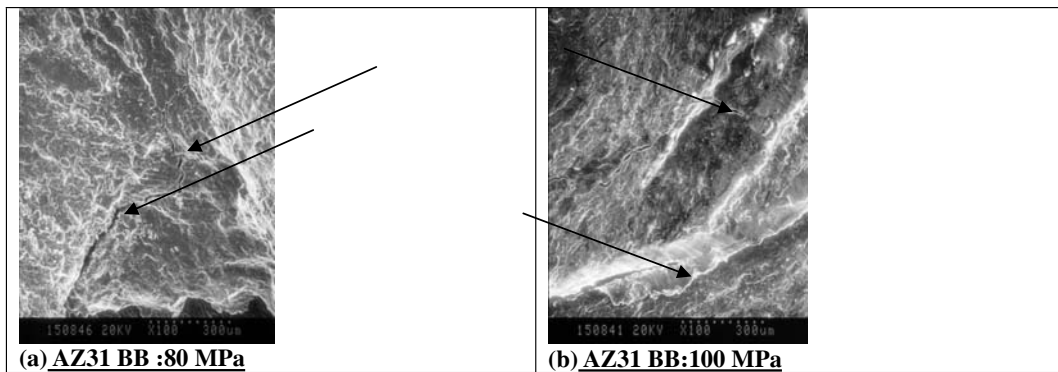
Fig. 5. SEM micrographs showing cracked surfaces at difference stress for BB at (a) 80MPa; (b) 100 MPa

The cracked line could be seen easily for higher stress for BB condition as fracture occurs in internal surface not at the outer surface as in the EP condition in Fig. 5.
