INFLUENCE OF HEAT TREATMENT PARAMETERS, TEMPERATURE AND TIME, ON WEAR AND MICROHARDNESS OF NICRBSI FLAME SPRAYED COATINGS APPLIED ON CK45 SUBSTRATES

Abstract: The objectives of this research were to find an economical way of reducing porosities in the microstructure of coatings deposited by flame spraying technique on CK45 steel and also trying to increase their cohesive strength to the substrate, so that the overall wear properties of this type of coating can be improved. So several specimens from this steel coated with NiCrBSi powder under specific conditions were subjected to various furnace heat treatment at 1000, 1025, 1050, 1075 and 1100 °C, each for periods of 5, 10 and 15 minute before cooling them in air. Tribological properties of treated coatings were evaluated by pin on disc method. The results show the highest wear resistance and microhardness values observed in one of the sample was due to lower amount of porosity and higher amount of very fine Cr₂Ni₃B₆ particles precipitated homogeneously throughout its microstructure during specific heat treatment.

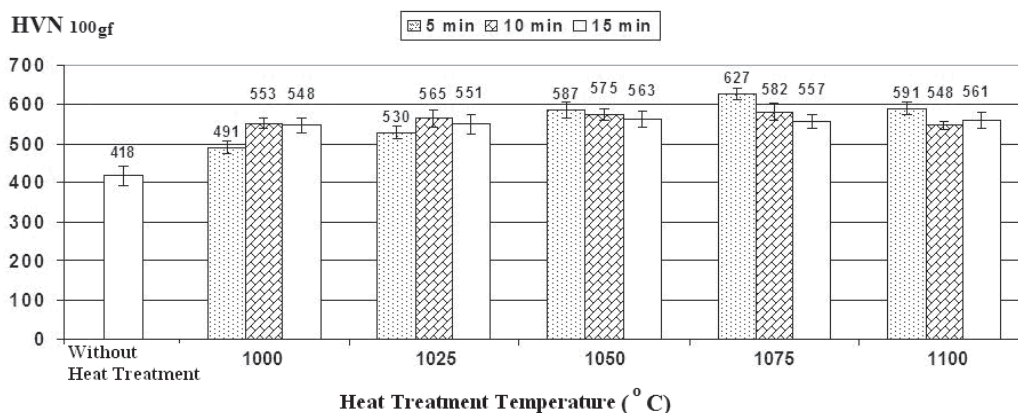
Fig. 7 shows when the time of heat treatment increased from 5 to 15 minutes only a little change occurred in hardness values, but the sample treated for 15 minute at 1100 °C lost its hardness substantially particularly up to a

Fig. 7. The mean microhardness profile of substrate/coating cross section of coatings treated at various temperatures and 15 minutes

distance of 150 μm from its interface from the substrate. This observation might be related to the formation of $\text{Cr}_2\text{Ni}_3\text{B}_6$ precipitates in 100-S-15 sample that was mentioned in previous sections. The coating microstructure of this sample can be seen in Fig. 5.
