FATIGUE BEHAVIOUR OF A ROLLED AZ31 MAGNESIUM ALLOYS PREPARED BY EP AND BB CONDITIONS

Abstract: Rotating bending fatigue tests have been performed using smooth specimens of a rolled AZ31 magnesium alloy in laboratory air at ambient temperature. Fatigue strength and characteristic was evaluated and fracture mechanism was discussed on the basis fracture surface analysis. Electrical polishing (EP) as well as deep rolling (ball burnishing (BB)) U-notched specimens were performed on two groups of samples, to evaluate optimum conditions for fatigue life. The microstructure and tensile properties of roll cast (RC) Mg- 3% Al- 1% Zn (AZ31) was investigated. The fatigue strength of 107 cycles around 100 MPa for deep rolling while it was around 40 MPa for Electrical polishing. It was very important to understand the effect of (ball burnishing (BB)) conditions on the hardness of the surface through to the core. The two procedures improved the fatigue performance, but better improve in results were found in ball burnishing. The growth of small cracks initiated at the surface coincided with the FCP characteristic after allowing for crack closure for large cracks, but the operative fracture mecha

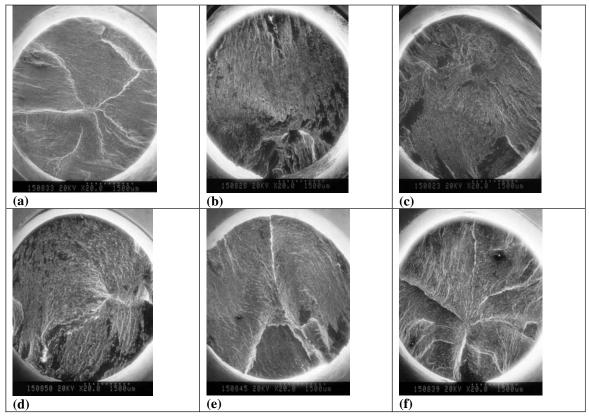
Fig.4. SEM micrographs showing fracture surfaces at difference stress for EP at (a) 60MPa; (b) 80 MPa; (c) 100 MPa and BB at (d) 60MPa; (e) 80 MPa; (f) 100 MPa.

The fracture surface of AZ31 for EP condition and BB condition at different stress is shown in Fig. 4. Subsurface crack initiation occurred at applied stresses at 60 MPa. At BB condition but it can be seen for both 80 and 100 MPa stress for EP condition. The S–N diagram is shown in Fig. 2. It is well known that fatigue limit does not exist in non-ferrous alloys, thus fatigue tests were continued until 10⁷ cycles. At EP condition σ = 40 MPa, fatigue failure did not occur, but non-propagating cracks were observed on the specimen surface. As can be seen in the figure, the present Mg alloy seems to possess a definite fatigue limit, which may be related to the existence of non-propagating cracks. The fracture mode depending

on applied stress level, above 60 MPa cracks initiate at the surface (surface fracture), while below that stress at the interior of the specimen (subsurface fracture). Subsurface fracture is a very interesting finding, which has not been recognized in Mg alloys, for both EP and BB conditions.

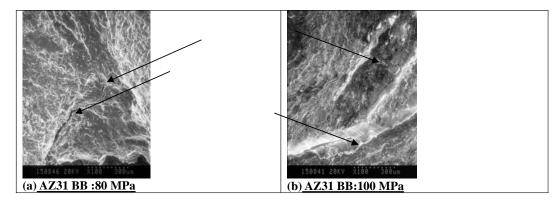
Fig. 5. SEM micrographs showing cracked surfaces at difference stress for BB at (a) 80MPa; (b) 100 MPa

The cracked line could be seen easily for higher stress for BB condition as fracture occurs in internal surface not at the outer surface as in the EP condition in Fig. 5.
